**Bond Release Geodatabase
for a surface coal mine in Wyoming**

Project Objectives:

- ▶ Develop a Geographic Information System (GIS) Bond Release **Geodatabase** to track **the verification of environmental performance standards** and reclaimed areas that have achieved bond release at the North Antelope Rochelle Mine (**NARM**).
- ▶ Develop mobile computing procedures utilizing a Geographic Positioning System (GPS) to verify the reclamation and bond release **compliance requirements** during inspections.
- ▶ Develop **a system of spatial data exchange** between the Land Quality Division (LQD) of the Wyoming Department of Environmental Quality (WDEQ) and the operator for sending, verifying, and approving features of the Geodatabase.

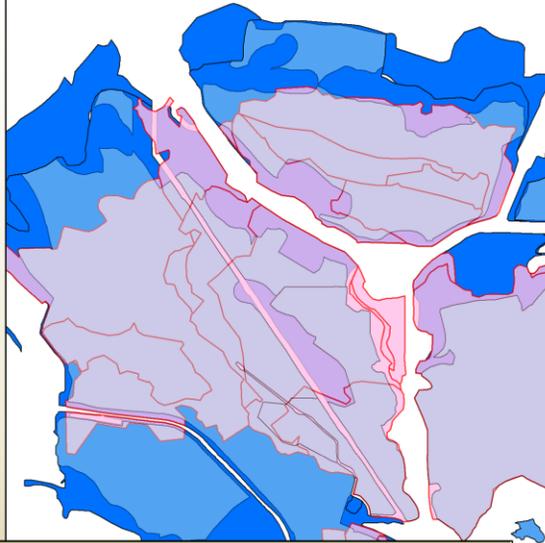
- Variable acreage (0.1-482 acres) of rough backfill/quality areas (in a process of verification or bond released) throughout the mine.

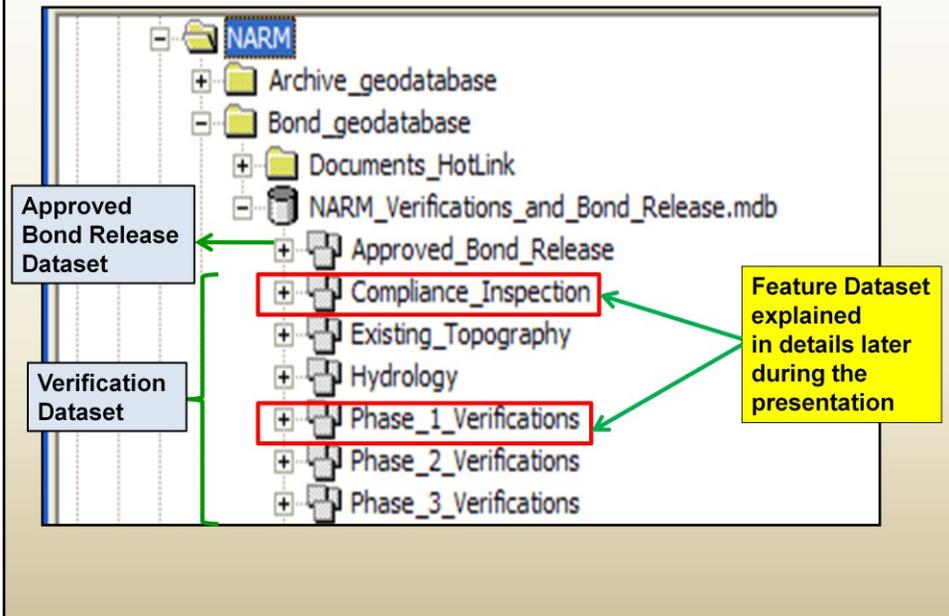
Bond Release Geodatabase structure stored on computer:

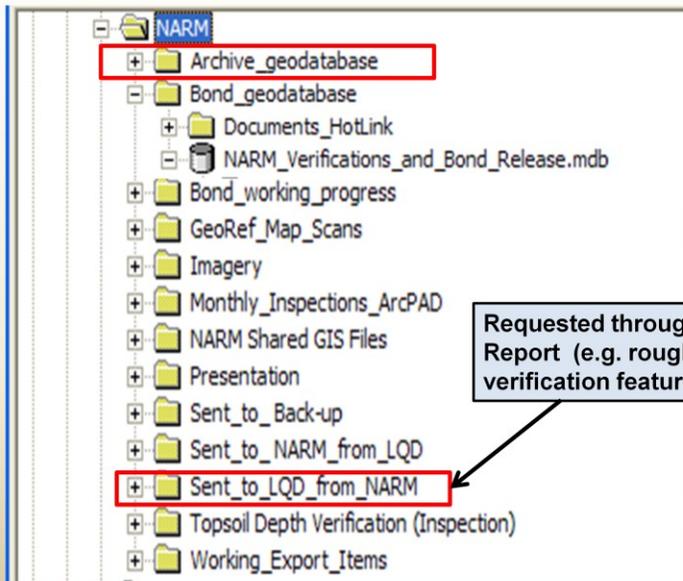
Structure of file folders supporting the Geodatabase :

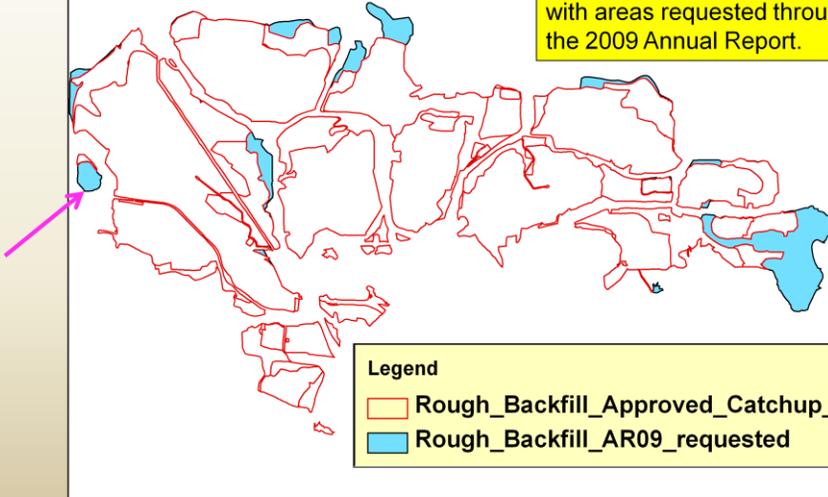
Bond Release Verification of the Rough/Quality Backfill feature class

Comparing already verified rough/quality backfill areas with areas requested through the 2009 Annual Report.

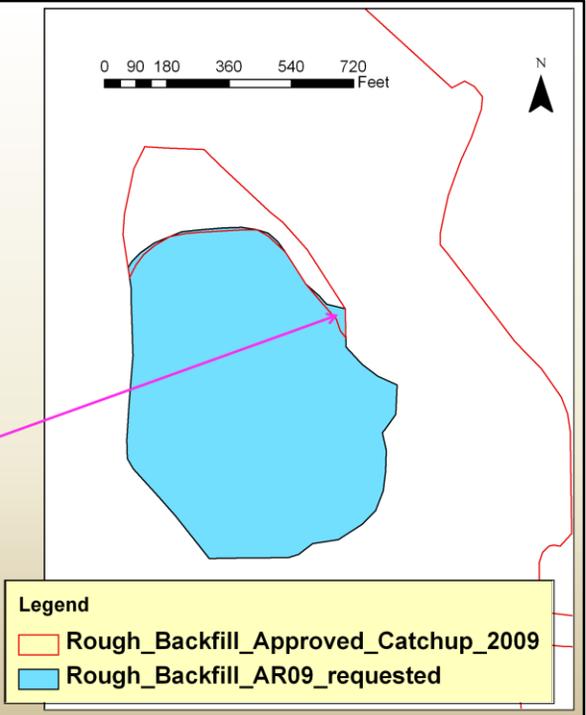
**“Office” verification
of rough/quality
backfill areas**

Rough/quality backfill areas
discrepancy was found between
areas already verified
and areas requested through
the 2009 Annual Report

This portion of the
area has been
already verified.

One of the area requested
for the rough/backfill
verification needs
to be revised.

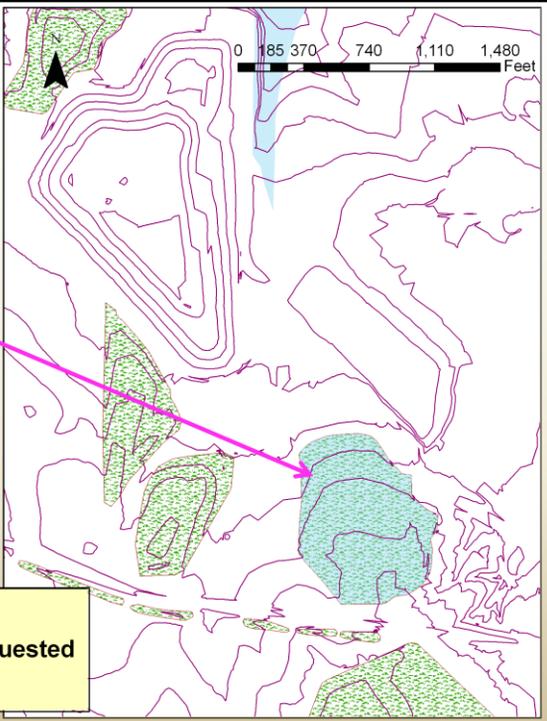
“Field” verification of rough/quality backfill areas

Comparing requested rough/quality backfill area with the “Topsoil Stockpiles” feature class layer.

One of the requested area was the same as the topsoil stockpile located on native area. The 40 acres area needs to be removed from the request.

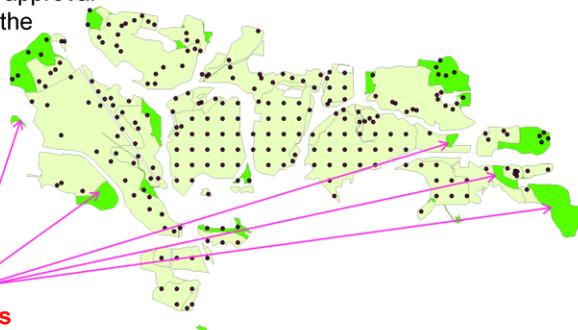
Bond Release Verification of the topsoil depth feature class

Using Geodatabase to compare:

- ◆ Topsoil polygons already approved
- ◆ Topsoil polygons requested for approval
- ◆ Topsoil depth points verified in the field

Requested - 654 acres

Verified - 403 acres

Additional verification needed - **251 acres**

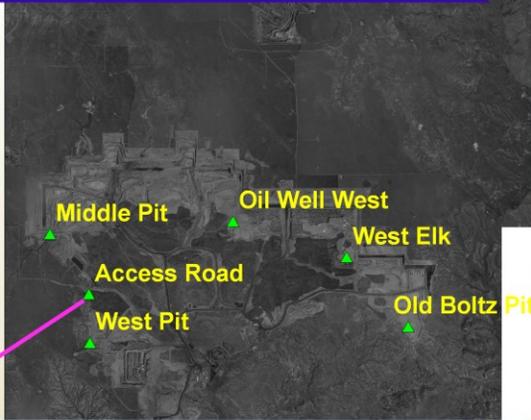
**Review of mining and reclamation progress (Photo_pit)
GPS location of where photographs were taken**

Photographs were taken from the same six GPS location sites throughout the years. The progress of mining and reclamation activities was compared with the existing permit. An example of the documented progress is shown for the "Access Road" GPS site, on the next slide.

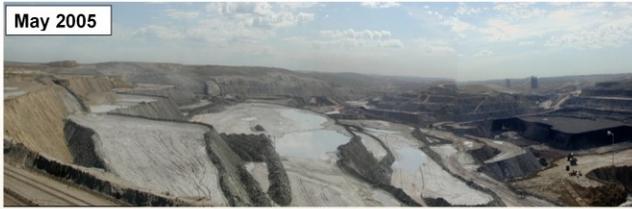
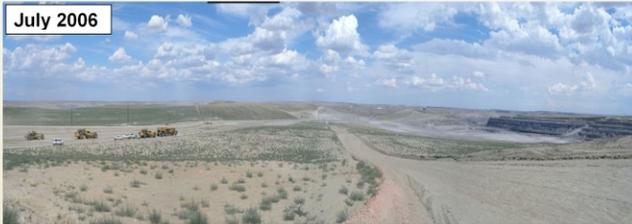
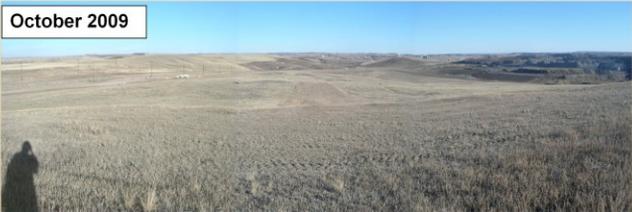
Access Road -
Photo_pit

View of the
reclamation progress
over several years in
the northern portion
of the Western Pit

May 2005

July 2006

October 2009
