Use of Borehole Camera to Explore a Shallow Mine Void
OSM Western Region's Denver Field Division
Abandoned Mine Land (AML) Program
January & February 2011

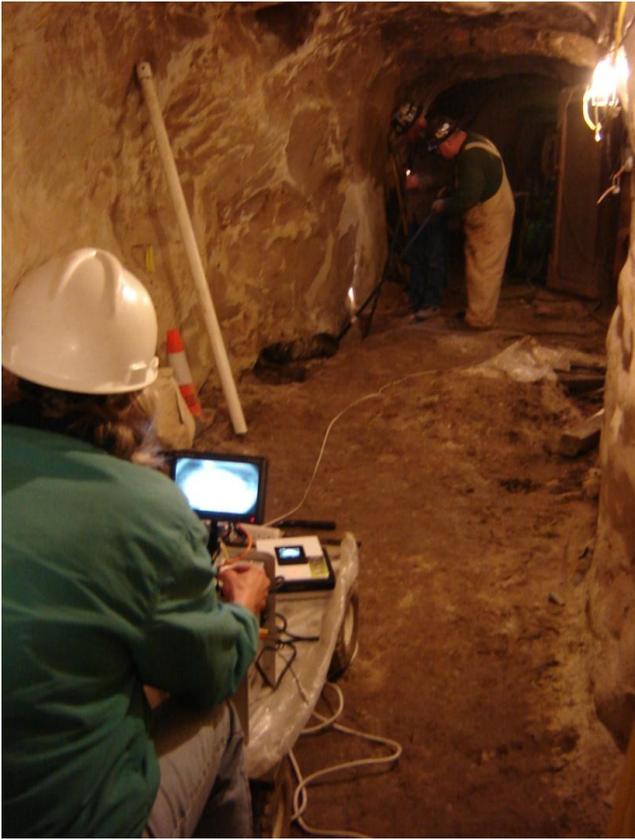
Lowering the camera down the drill hole from inside the mine museum

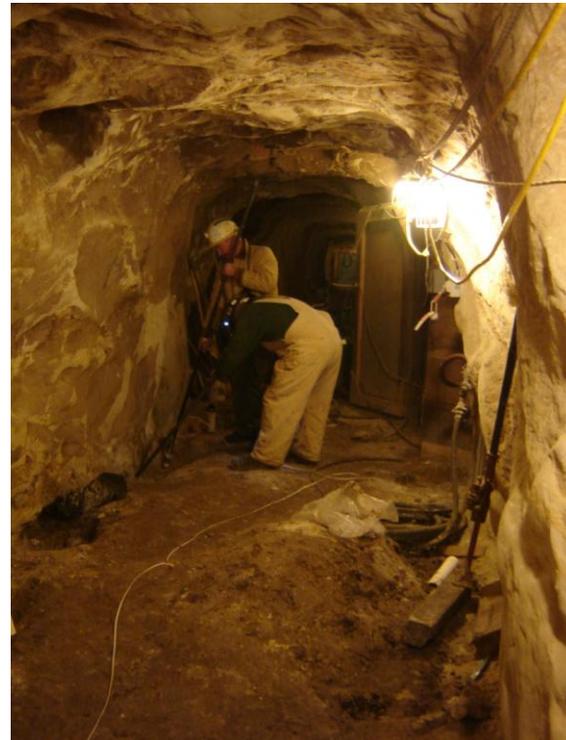
The roof of the mine void is about four feet below the museum floor. With a small LED light on a rod lowered down one of the seven exploration holes for illumination, we were able to lower the borehole camera and turn the camera at the angles we needed to view the void. The camera's mounted compass meant that staff knew exactly where the camera was pointing at all times. To explore the extent of the void, we moved the camera and the light source from hole to hole. It was easy and effective.

Camera in 1 hole and a light source in another hole

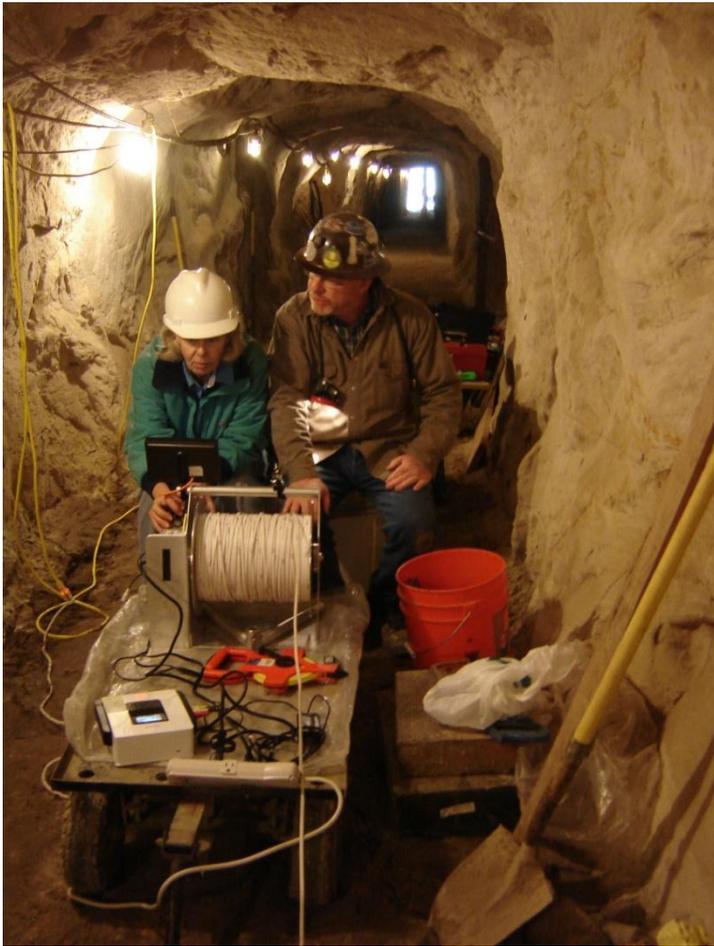
Looking at voids on the monitor

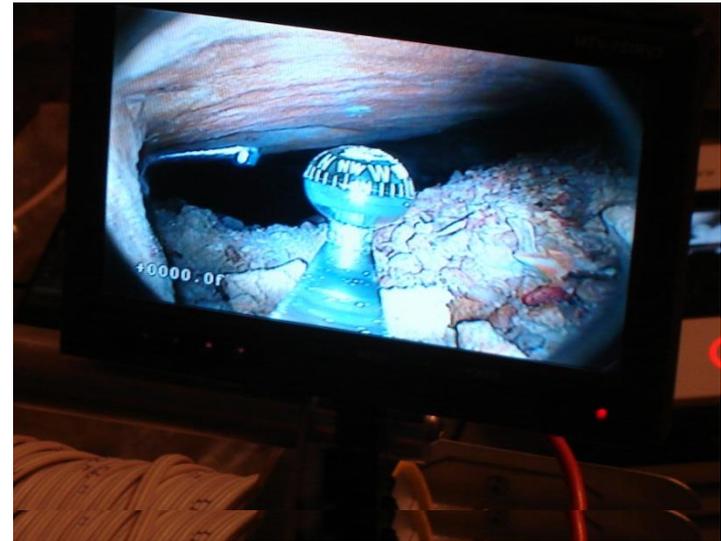
OSM's Western Region AML staff used the borehole camera to explore and define the extent of the void affecting public space. Park staff used a corehole drill to drill 7 exploration holes. We found that the coal mine void on the 30-degree dipping Clark seam is 4 feet below the sand mine floor. The coal void is open for a height of about 3 feet. This shallow coal mine room is directly below public access into the museum. High levels of CO₂ are present. The data obtained from the borehole camera exploration is being used to develop a reclamation plan to fill the coal mine void and thus eliminate both the flow of CO₂ gas and subsidence potential under the mine museum entry.

Mine voids on the monitor
